**A.S.T.C.**  
**REMEDIATION SRL**

## ISCO-Application - How we evaluate and operate

# Underground water reclamation polluted by Solvents

## In site remediation at a printing company of underground water polluted with toluene by oxidation (ISCO)

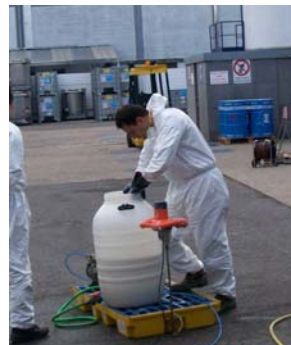
After the preliminary investigations and the start up of hydraulic barrier the polluted area has been detected. The storage tanks located into the ground cut the water table and locally modified the water table flow.

The tanks and the plants into the ground didn't allow a venting remediation system for the soil and the round water, it was necessary too avoid any stop to plant production.

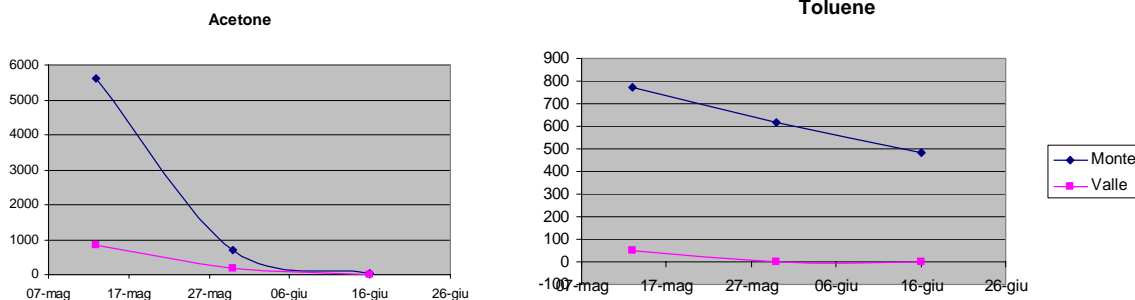
The two diagrams below highlight the Acetone and Toluene trend into the upstream and downstream wells after the treatment.

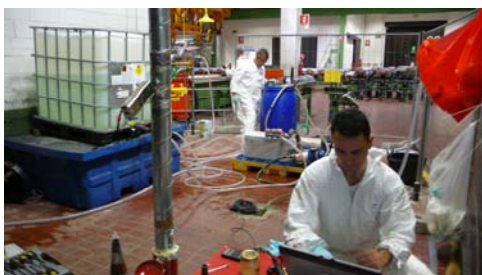
The project approved and authorized by the Authorities, is divided in two steps: the preliminary one includes the field test and the final one extended to the entire polluted site.

The field test highlight the efficiency of the methodology selected. The chemicals quantities to inject has been dimensioned by a bench test in our lab and by a mathematical model to take in account the specific geology, geochemistry and hydrology of the polluted area.

The field test was carried on where the toluene pipe leaked. The oxidizers (persulfate and hydrogen peroxide) properly activated were injected with following cycles.

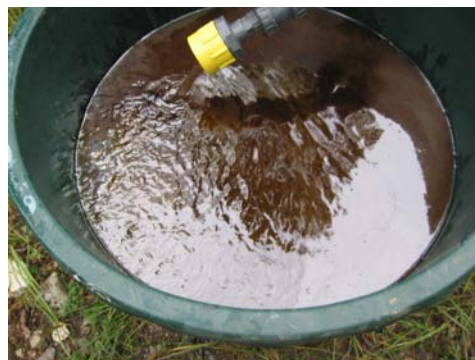
The area is characterized, below the filling layer, by a sand and gravel level with silt lenses till 14 m of depth leaned on a clay layer that bind the first aquifer. The water table is located round 2 – 3 m below ground surface (bgs).

The clay layer stopped the PAH's movement and created a contaminated layer of different thickness. Below the distillation plant this level reaches 1 m of height. The concentration detected is >8,500 mg/kg.

An hydraulic barrier has been put in place after preliminary investigations to hold the underground diffusion. The on site oxidation approach, had to test:
